**DEVELOPMENT OF PLATFORM
AIM
(ASSESSMENT, INSPECTION, & MAINTENANCE)
PROGRAMS
PHASE IV**

FINAL REPORT

PMB ENGINEERING INC.

MAY, 1990

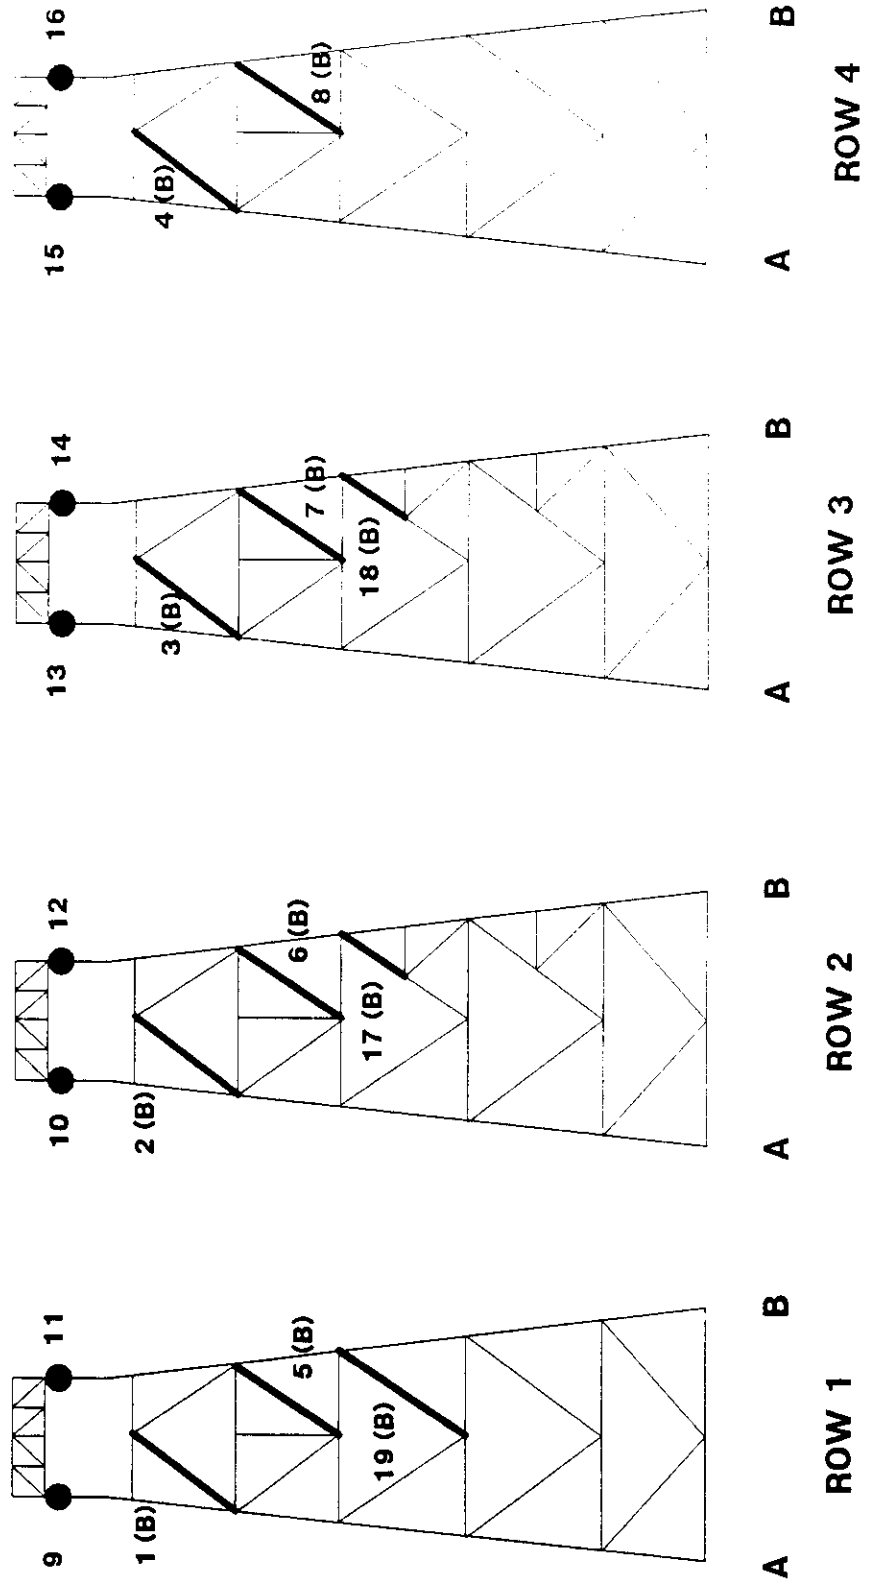
PLATFORM D
Analysis 2

<u>ELEMENT</u>	<u>DESCRIPTION</u>	<u>LOAD LEVEL</u>
3305	Buckled	0.75
3405	Buckled	0.75
3503	Buckled	0.75
3603	Buckled	0.75
3313	Buckled	0.85
3413	Buckled	0.85
3509	Buckled	0.85
3609	Buckled	0.85
102	Hinge @ 281 (i)	0.85
202	Hinge @ 285 (i)	0.85
502	Hinge @ 211 (i)	0.85
602	Hinge @ 215 (i)	0.85
302	Hinge @ 295 (i)	0.85
702	Hinge @ 225 (i)	0.85
402	Hinge @ 291 (i)	0.85
802	Hinge @ 221 (i)	0.85
3417	Buckled	0.85
3513	Buckled	0.85
3317	Buckled	0.85

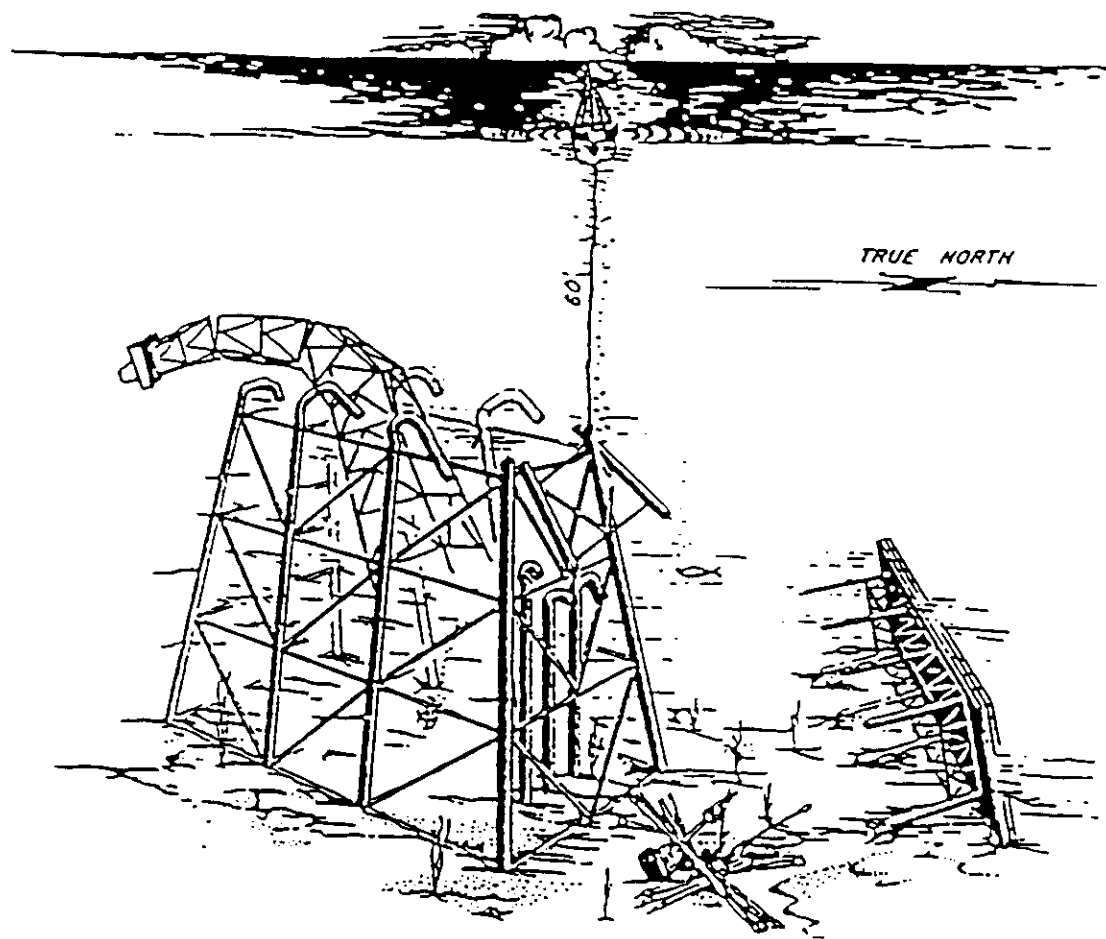
Platform "D" Failure

PLATFORM D
FAILURE SUMMARY

- Failure occurred in the structure
- No evidence of foundation failure
- Appears that jacket bracing failed allowing legs to rupture
- Lower portion of jacket below El.(-)60' remained intact
- One or two legs reported to have a "shear" failure at El.(-)60'
- All other piles at El.(-)60' bent over
- Derrick draped over jacket indicating immediate failure of platform and not a "progressive" failure from a series of waves
